*Our northern runway: making best use of Gatwick*

Preliminary Environmental Information Report  
Appendix 10.9.1: Preliminary Risk Assessment  
September 2021

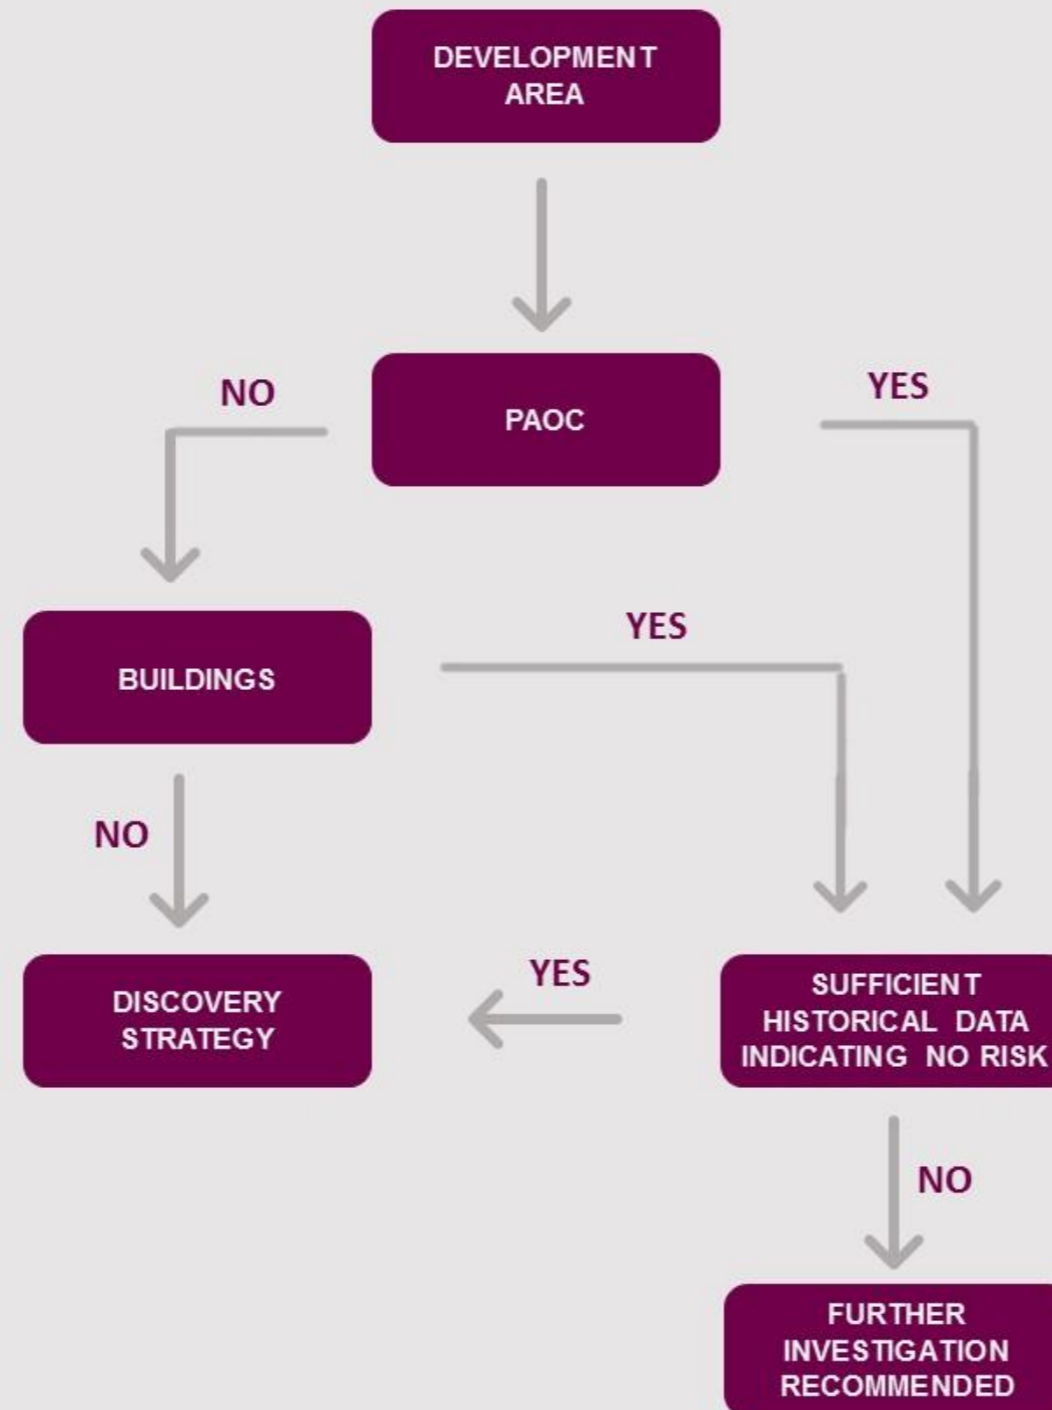
## Recommendation Strategy for Further Works

- pre-existing site investigation data, where available.
- 5.1.4 A flowchart detailing the recommendation strategy for further works is provided in Annex 6 together with a table detailing recommendations for each development area.

**Table A6.1: Recommendation Strategy for Further Works**
